GARNISS POND DAM  
CT-00114

NATIONAL DAM INSPECTION PROGRAM  
CORPS OF ENGINEERS

4. TITLE (and Subtitle) East Haven, Conn. (Garniss) Pond Dam NATIONAL PROGRAM FOR INSPECTION OF NON-FEDERAL DAMS		5. TYPE OF REPORT & PERIOD COVERED INSPECTION REPORT

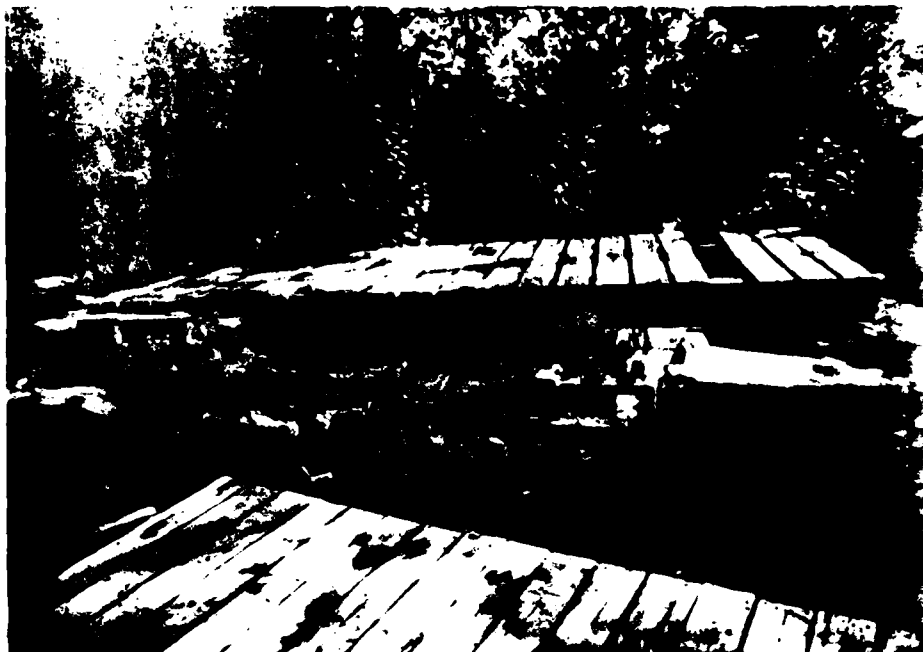
The findings of our visual inspection revealed that the condition of the dam is poor. The upstream weir is deteriorated and has fallen to a state of disrepair (Photo Page 3). The downstream weir has several areas of seepage at the downstream side (photo 5 and 6). The crest and slopes are overgrown with trees and brush (photos 1 and 2).

*Photo 3 - Upstream weir and spillway channel. Downstream weir in background.*
